Castle Cement Limited

Carbon Capture and Storage Project – Padeswood, North Wales

Volume 4, Draft Technical Appendix 8.3

Heritage Significance Technical Note

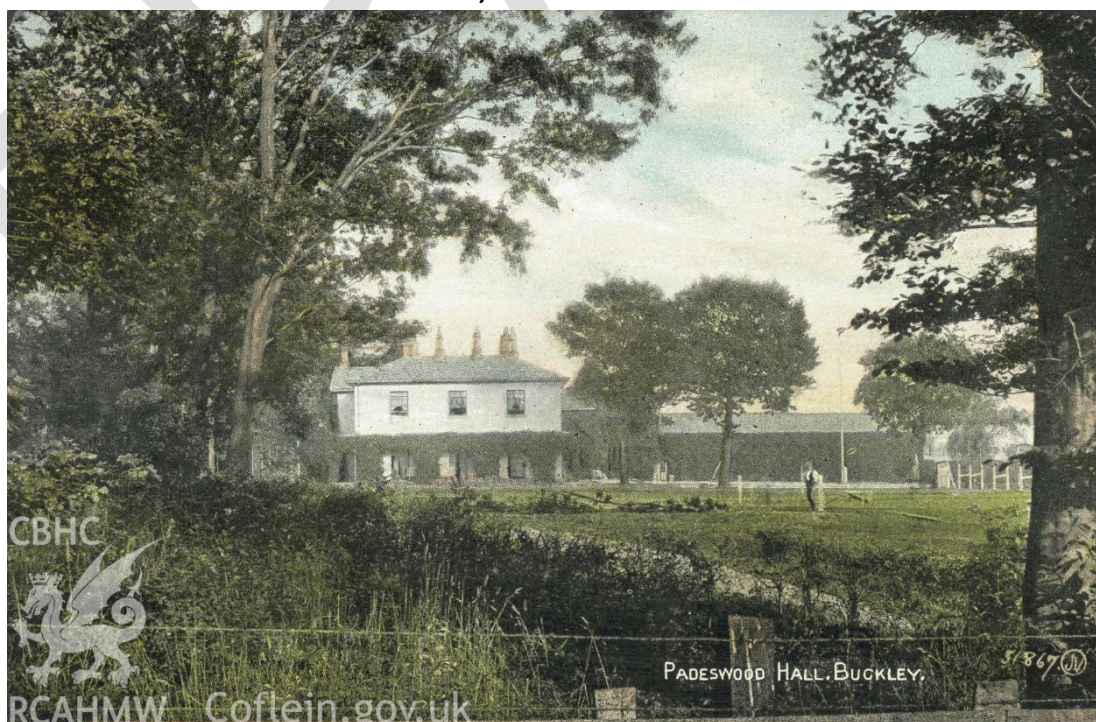
Figure 2 1905 Postcard of Padeswood Hall (Royal Commission on the Ancient and Historic Monuments of Wales)

- 4.1.3 The Royal Commission on the Ancient and Historic Monuments of Wales contains a separate entry for Padeswood Hall (NPRN 409419), describing the building as *“a substantial 2-storey hipped-roofed house.”* The surrounding garden is separately identified by the Royal Commission on the Ancient and Historic Monuments of Wales as asset NPRN 266274 (*“This garden is depicted on the Second Edition Ordnance Survey 25-inch map of Flintshire XIV, sheet 10 (1899). Its main elements on that map include greenhouse, kitchen garden and lawns.”*). Both are depicted in a postcard dated 1905 (**Figure 2**).

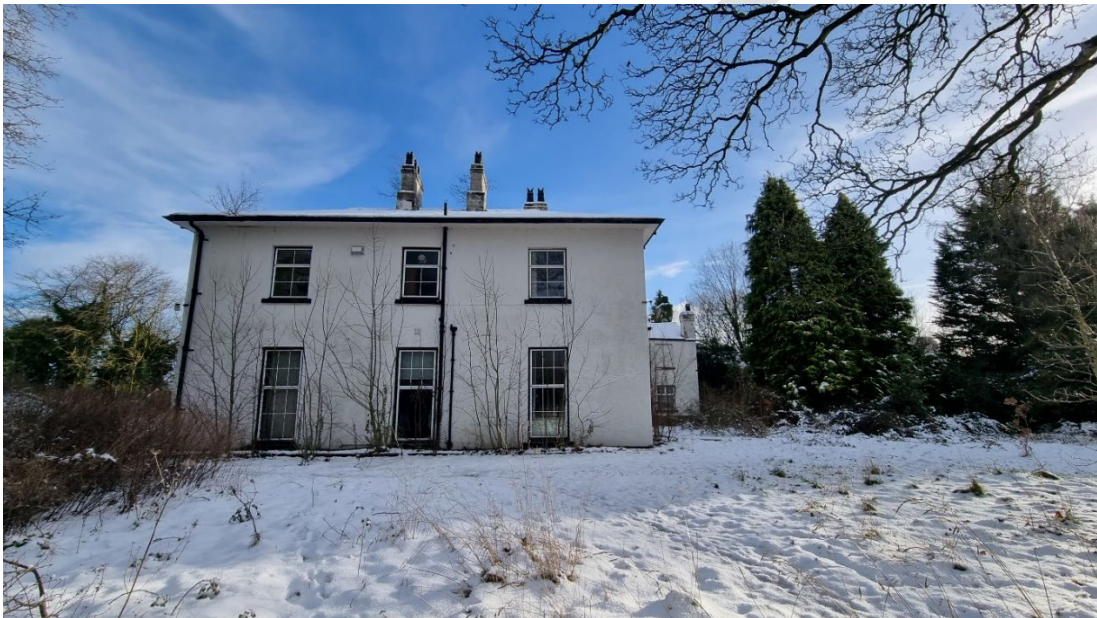
Figure 3 Padeswood Hall western elevation

- 5.1.1 Padeswood Hall is a multi-phase structure, the western portion dating to c. 1840-41, with substantial modifications to the rear made between 1898 and 1908 (illustrated in **Figure 3**). The ubiquitous painted render finish prevents close analysis of the phasing.

- 5.1.2 The main structure comprises a two storey plus basement, three-bay house of rendered brick construction. Externally the render is painted white. The roof is hipped with slate tiles and projecting eaves, through which iron rainwater goods project. There are four chimney stacks with square-sectioned, embossed ceramic pots. The principal elevation faces west across the former gardens, with three full height windows on the ground floor and three at first floor level. The main entrance is on the northern elevation which originally formed the main approach to the house, comprising a large unpainted timber door and surround with fanlight above.

- 5.1.3 To the rear is a two storey extension built between 1898 and 1908 with a pitched, slate tiled roof and chimney stacks. The extension projects forward of the earlier northern elevation, with two flat roofed, canted bay windows at ground floor level. The extension obscures the rear elevation of the earlier structure. Further outriggers at the back of the building were added between 1898 and 1908, incorporating part of the former western farm building range.

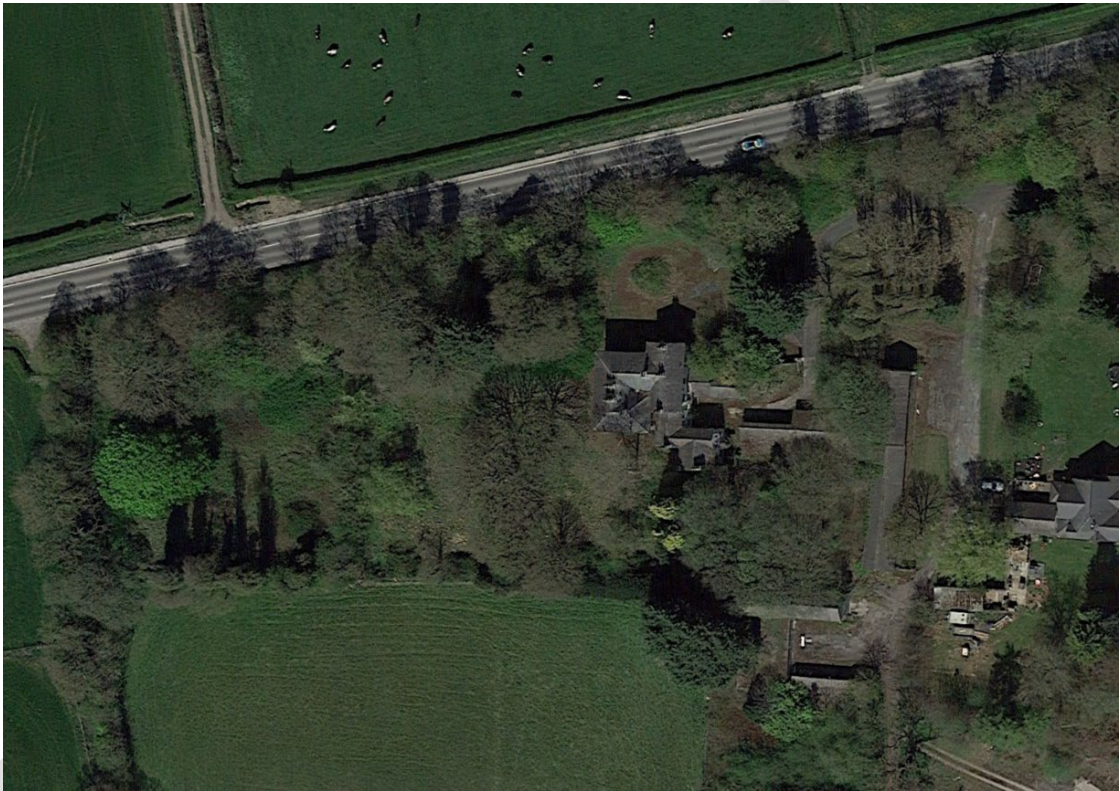
Figure 4 Aerial View of Padeswood Hall and Gardens

5.1.6 The gardens to the hall surround the west and south of the building. At present these are heavily overgrown, and at the time of survey were snow covered. The gardens are relatively simple, comprising lawns with perimeter hedges containing mature trees. A more distinct belt of mature trees is present along the northern boundary of the lawn. Two mature trees and a specimen willow survive in the centre/western end of

- 5.1.7 Historic mapping indicates that originally the house had a separate entrance to the adjacent farm buildings. This comprised a short driveway approaching the house from the north east via an entrance from the main road. As depicted on the mapping, the driveway widened in front of the northern elevation of the house and included a turning circle for carriages/vehicles. These features still survive, though overgrown, as visible in aerial photography of the Site (**Figure 4**).

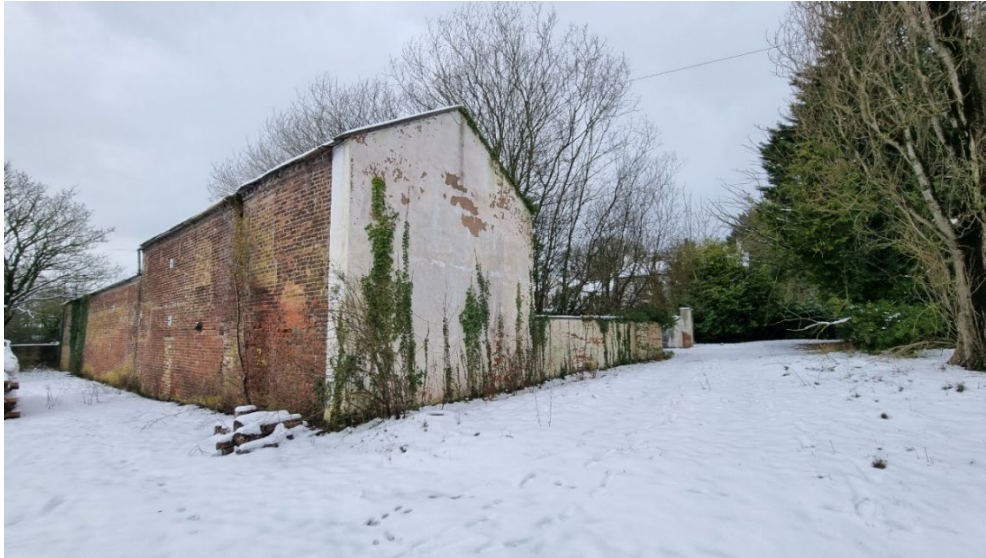
Figure 5 Padeswood Hall Farm Buildings, view to south west

- 5.2.1 The farm buildings at Padeswood Hall are arranged around a central, overgrown courtyard and comprise two principal ranges of two storey agricultural buildings to the east and south, two adjoining single storey buildings to the north and a range of single storey modern garages in a horseshoe configuration to the south of the southern range. A low, open sided shed is located in the centre of the courtyard.

- 5.2.2 The earliest structures are the eastern, southern and northern ranges which are likely to date to the 1840s, contemporary with (or possibly earlier than) the hall. The eastern and southern ranges are brick built, of two storeys with pitched, slate covered roofs. The northern range comprises two adjoining, slightly offset single storey sheds with shallow pitched roofs. The following observations were noted:

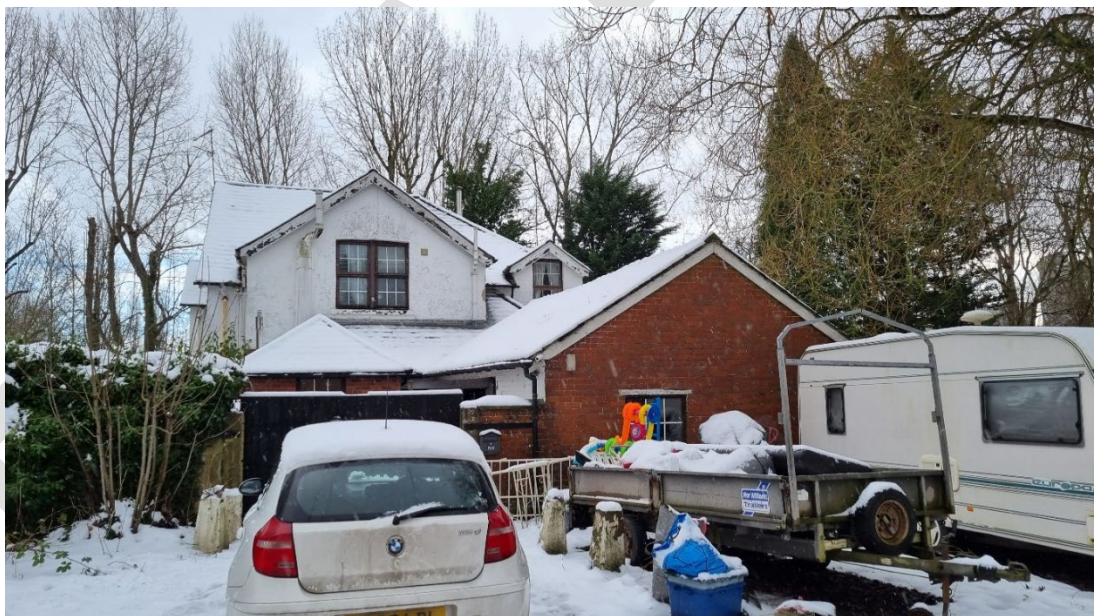
Figure 6 Padeswood Hall Farmhouse

5.3.1 The farmhouse (built between 1898-1908) is located to the east of the farm buildings and comprises a two-storey, brick built domestic house with exposed brick at the ground floor, rendered brick to the upper storey and gabled roof with slate tile coverings. The ground plan is irregular. From the visible areas seen during the site inspection there has been some modernisation with the introduction of uPVC windows and modern extraction flues. The house is currently occupied and assumed to be in good condition generally.
