Castle Cement Limited

Carbon Capture and Storage Project – Padeswood, North Wales

Soil Resource Assessment and Outline Soil Resource Management
Plan

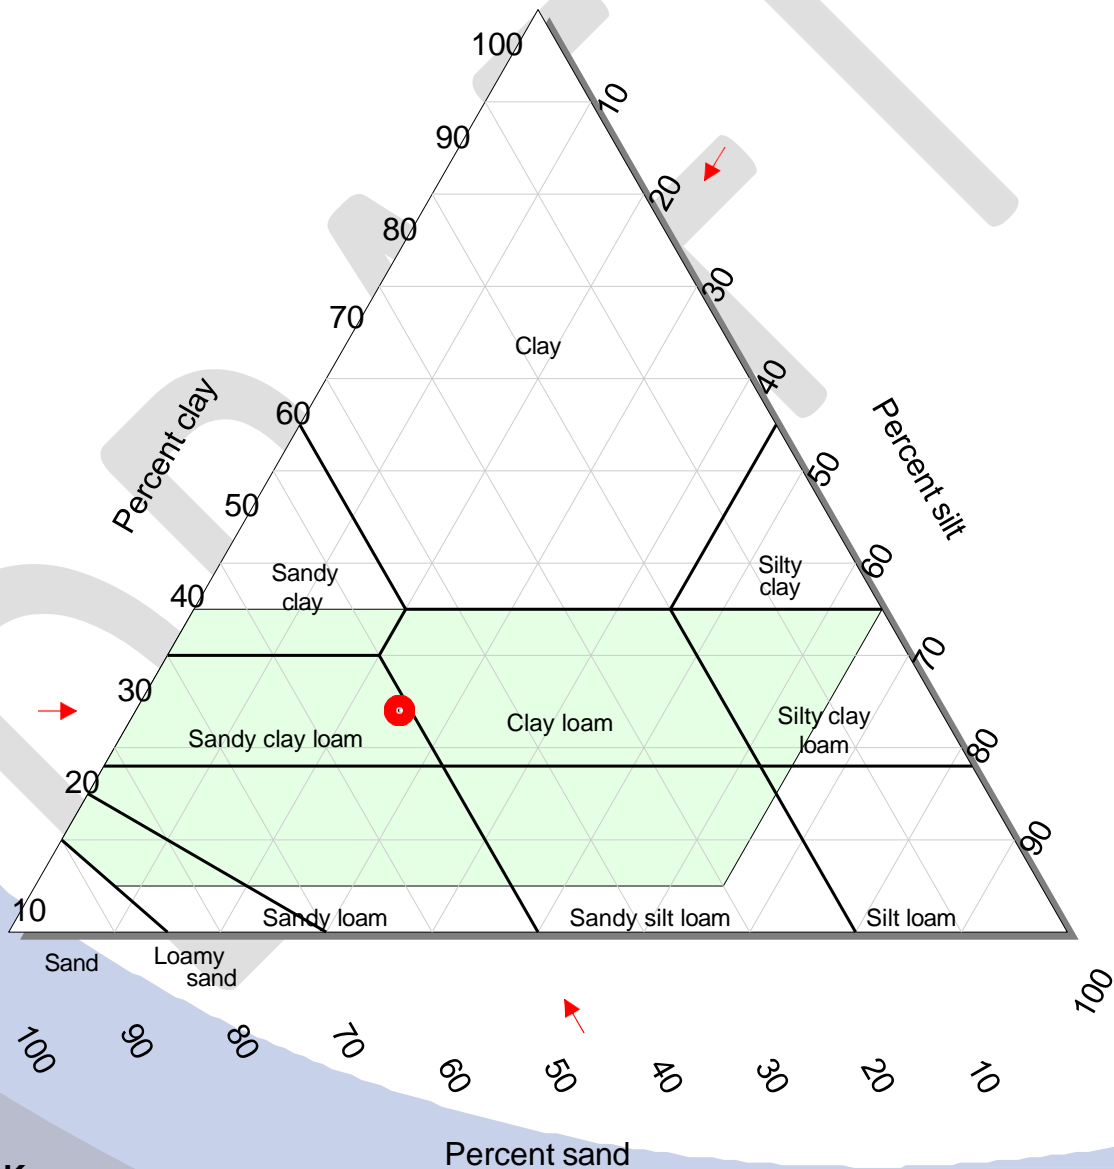
Fig. 1. Textural Class: Sandy Clay Loam (compliant)
