Castle Cement Limited

# Carbon Capture and Storage Project – Padeswood, North Wales

Volume 4, Draft Technical Appendix 5.2

Ecological Baseline Report (Animal)

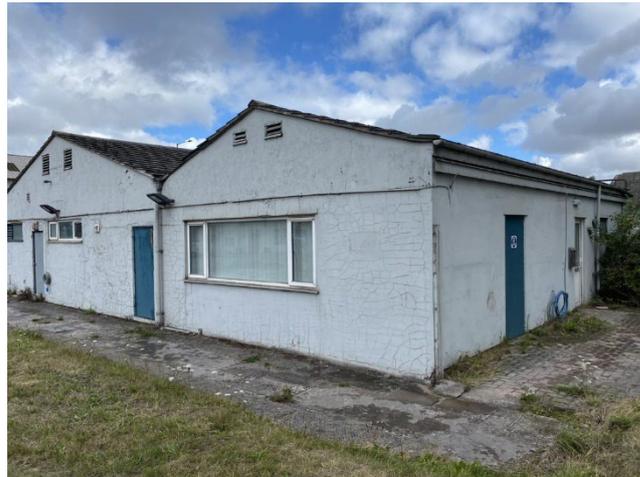
**Building 1** – Southern aspect, showing missing mortar and slipped tiles on the gable end of the eastern roof pitched roof

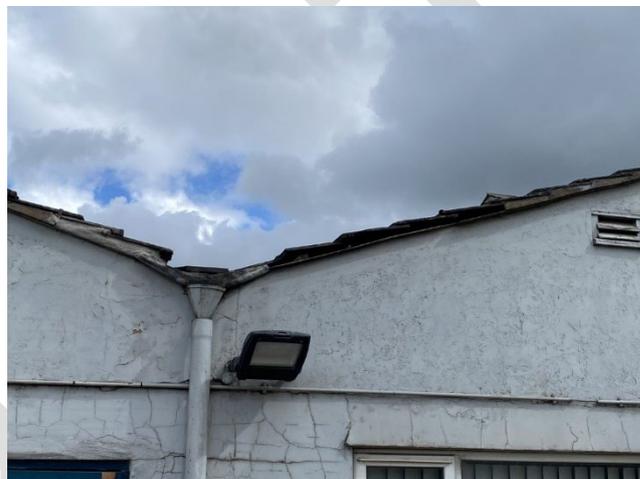
**Building 1** – Southern aspect, showing gaps in breezeblock work around timber doorframe offering potential roosting crevices for bats.

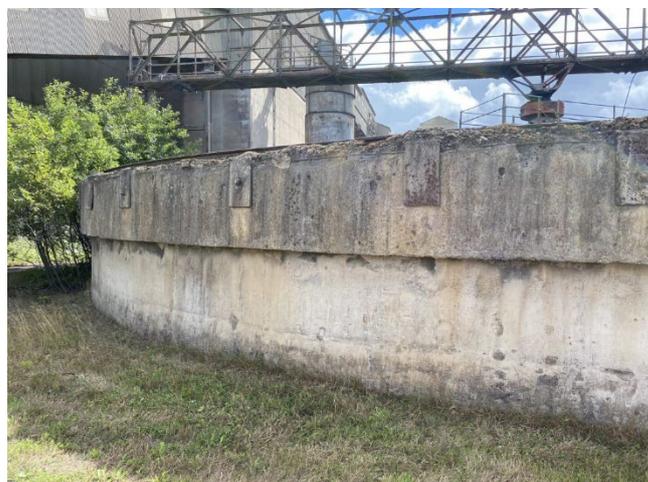
**Building 2** – Northern tank, showing external metal plate where central bolt has been removed, creating a smooth tunnel through the wall of the tank.

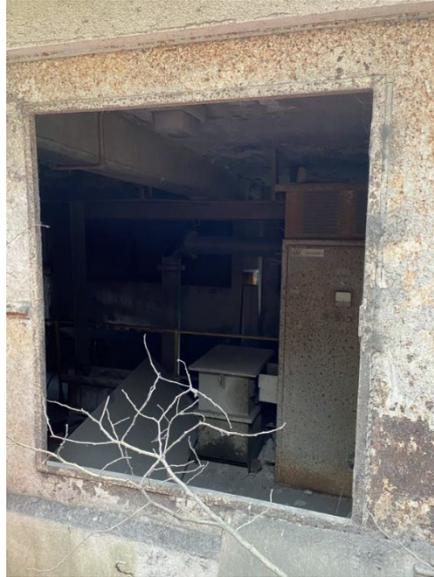
**Building 3** – View inside the building from missing window, shows the open door on the eastern aspect and internal beams and ducting offering potential roosting places for free hanging bats.

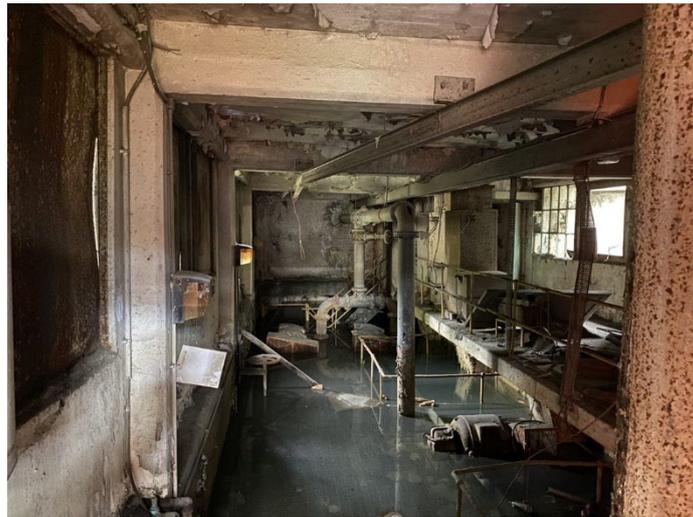
**Building 3** – View inside from the open doorway on the eastern aspect. Taken in December when water had been partially pumped out to enable access.

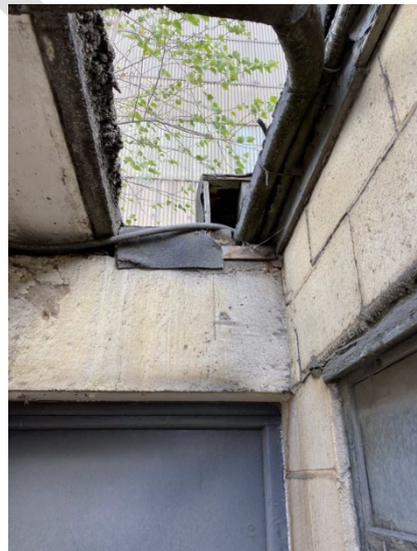
**Building 4** – View from inside shows the poor internal condition of the building. The roof has completely collapsed in places, making internal conditions far less favourable for roosting bats.

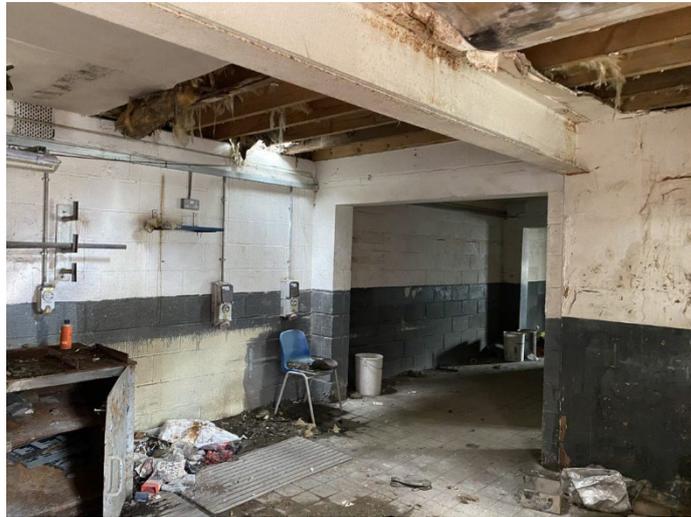
**Building 4** – View from inside at the eastern end of the main building, some potentially suitable crevices between the chipboard ceiling and the tops of the walls.

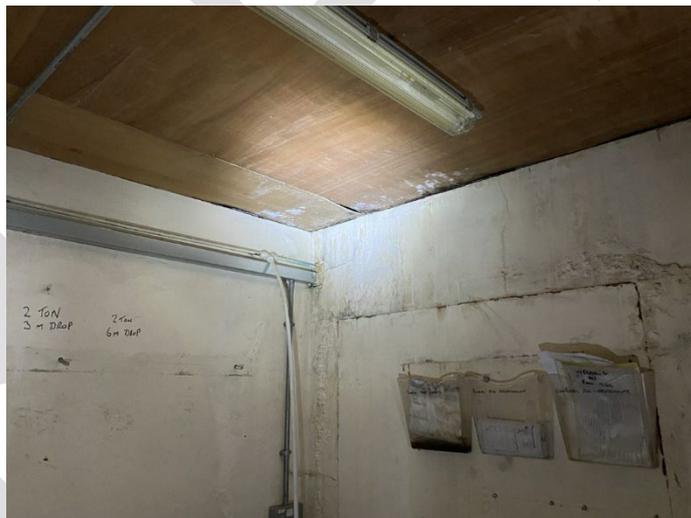
**Building 4** – View across the roof from the northern aspect, showing the wooden boxing visible from the recess on the southern aspect, several areas of peeling or lifted felt noted.

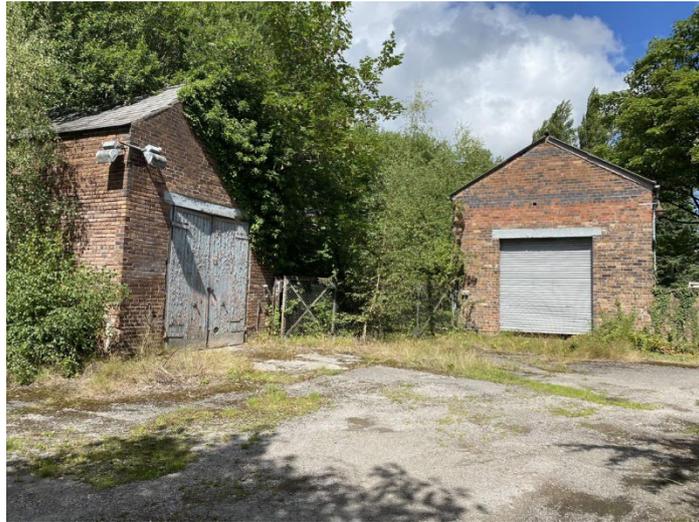
**Building 8** – Southern aspect, showing missing wooden fascia at gable end, which has uncovered damaged brickwork immediately below the roof line. The gable end ridge tile is open and above the garage door there is a brick missing from the wall. The metal roller shutter door has been left partially open.

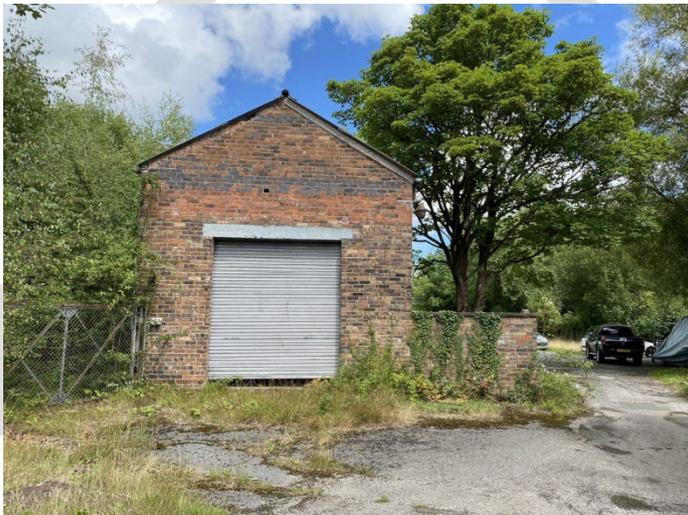
**Building 8** – Southern aspect a closer view showing the missing fascia which has exposed damaged brickwork beneath, a missing brick can also be seen on the wall beneath. The central ridge tile directly above the gable end is also open ended.

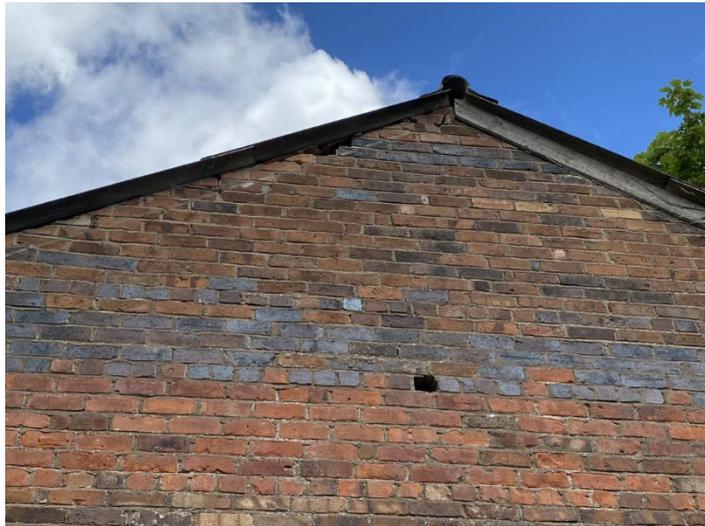
**Building 8** – Eastern aspect, showing the distinctly different northern and southern sections of the building. The taller northern section has a slate roof, whereas the southern section has an asbestos cement sheet roof and asbestos cement tiled ridge.

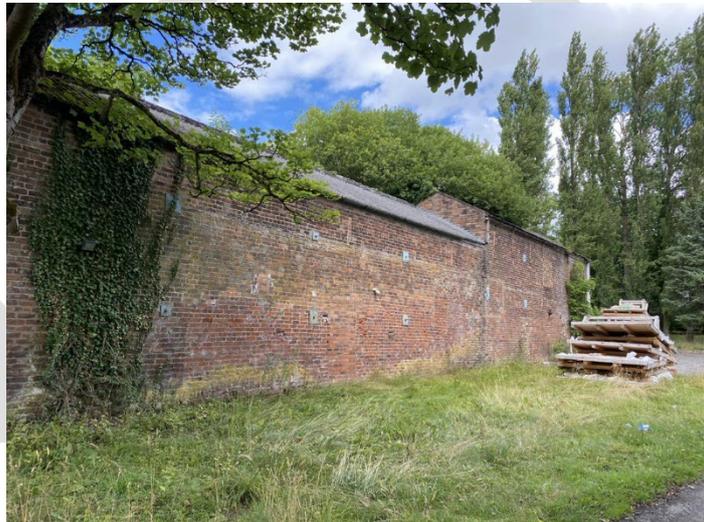
**Building 8** – Eastern aspect, showing missing mortar between asbestos cement roof sheeting and the timber fascia immediately below at the join between the southern and northern sections of the building.

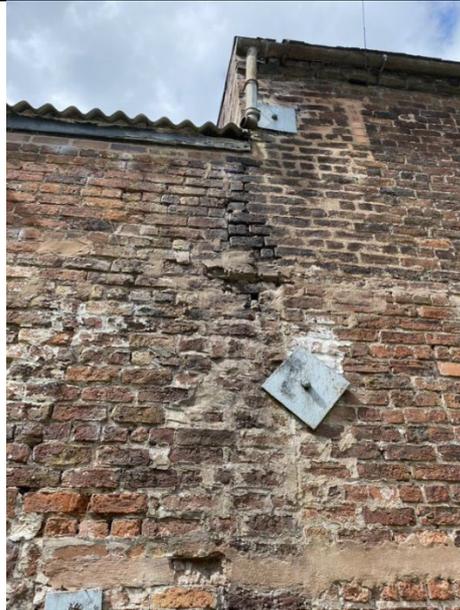
**Building 8** – Eastern aspect, showing a missing brick in the external wall, this was at lower level less <2m above ground.

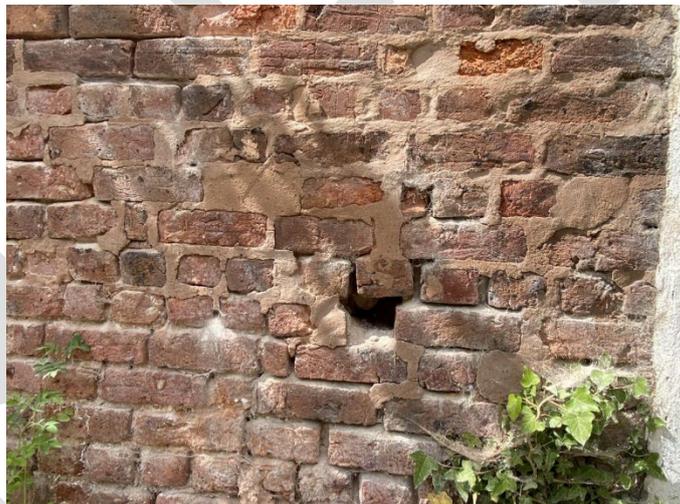
**Building 8** – Eastern aspect, slipped and partially lifted roof tiles noted towards the northeast corner, some eroded mortar immediately below roof line.

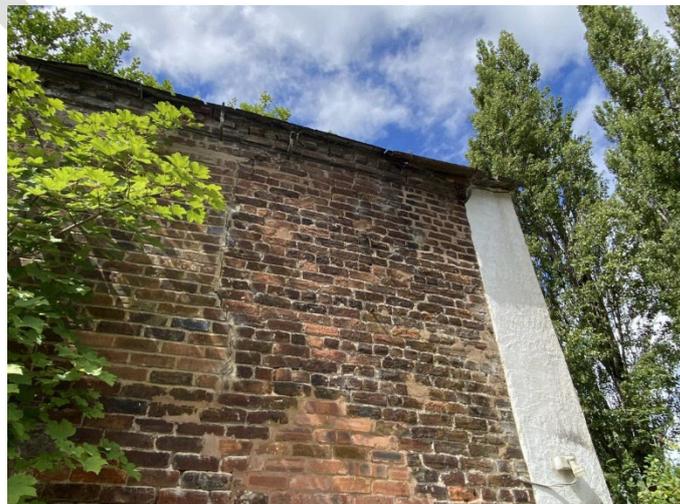
**Building 8** – Western aspect, showing extensive ivy growth over the walls and roof of the building, immediately adjacent the western walls is a dense stand of willow.

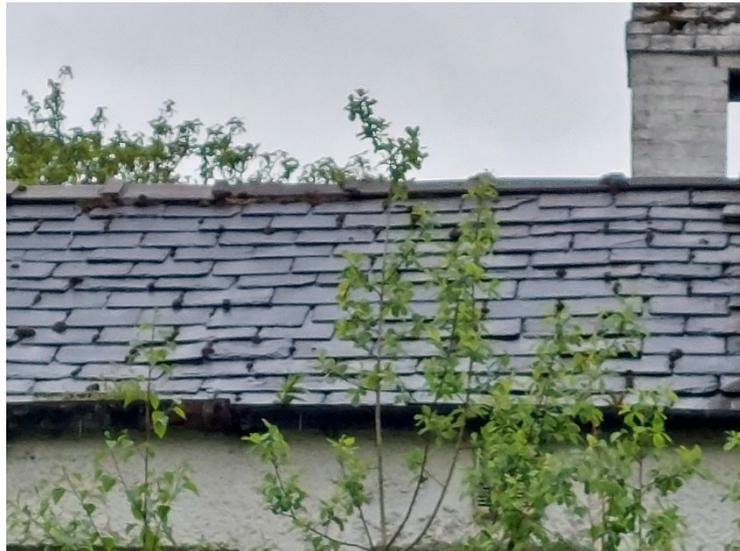
**Building 9** – Southern aspect, showing the boxed soffit damage.

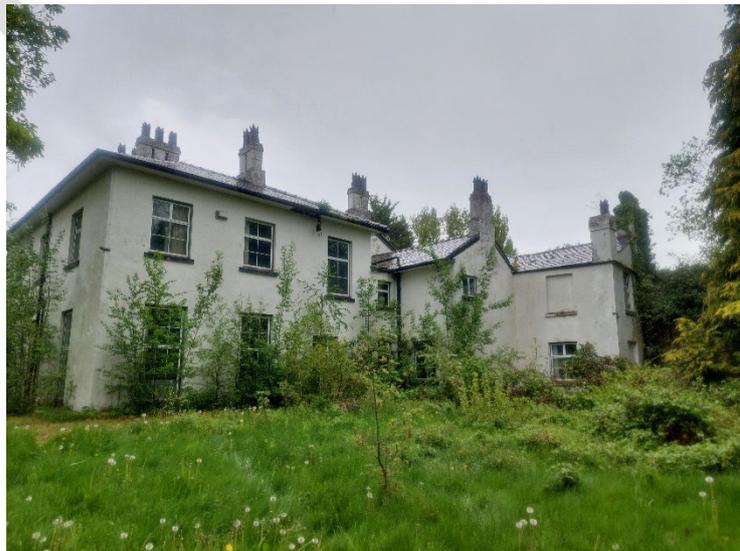
**Building 9** – Eastern aspect, showing roof damage.

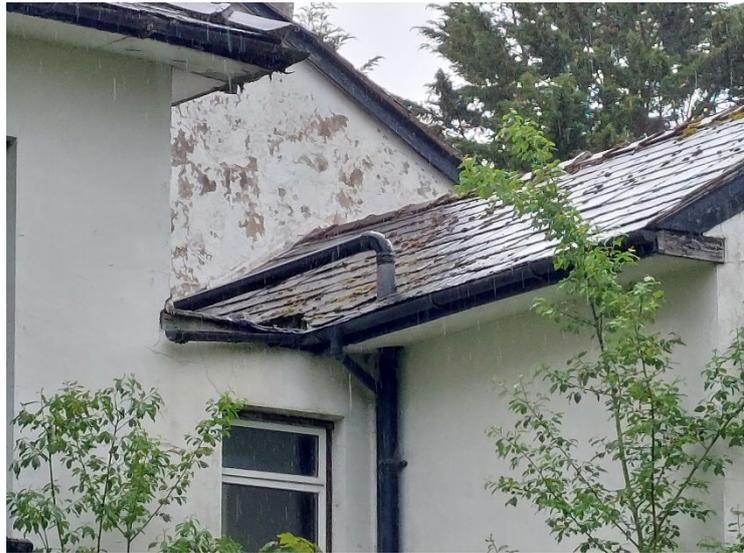
**Building 9** – Eastern aspect, showing gaps below ridge tiles on the building extension.
